Case Report

Prosthetic Hip Joint Infection: An Aluminium Mold for Intraoperative Production of Antibiotic-loaded Cement Hip Prostheses: 3 Cases Report

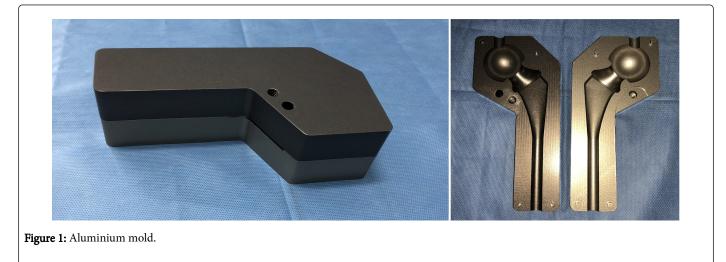
The mold was produced in a computerized CNC machine (DATRON Booth N-6021) and consists of 2 parts. It is made of high strength aluminium (AA7075 T6 3.4365; density 2.8 kg/dm³ and tensile strength 520 560 Nm/mm²) and coated by ANODE technique. Half of the coating penetrates into the base material, which results in an increase of 25 m, leading to a standard coating thickness of 50 m. The mold can be cleaned and sterilized for reuse (Figure 1).

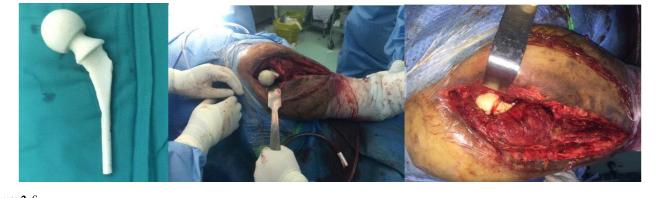
Figure 3: Spacer.

After 1 month, he checked up in Cho Ray hospital, his wound was healed, left leg function was good, and infectious condition was improved. Serological Tests: RBC 4.58 T/L, WBC: 6.66 T/L (Neu: 58.9%), CRP: 56 mg/L, Vs: 1 h 39 mm, 2 h 58 mm, Procalcitonin: 0.134 ng/ml (Figure 3).

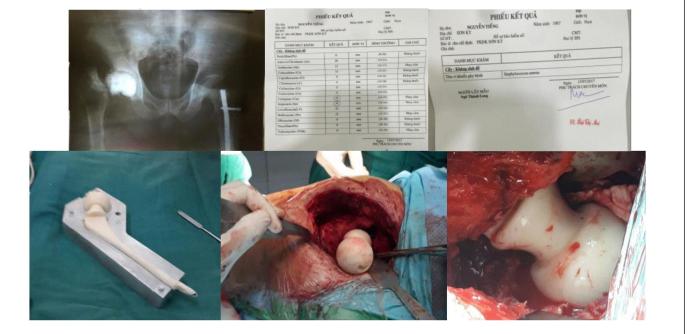
Figure 5: Antibiotic-loaded cement spacer.

On February 2017, his clinical improvement was too bad with pus from drainage incision. He has been admitted to that hospital, and underwent debrided, VAC in three times. On May 2017 he underwent debrided again, removed the prosthesis, used PROSTALAC (made by hand) and then transferred to Cho Ray hospital in the unimproved infectious condition. At Cho Ray hospital, he underwent debrided to remove the PROSTALAC, serological tests, synovial fluid tests, antibiogramme and VAC drainage. After 3 times debridement and VAC drainage, he was impregnated with antibiotic-loaded cement spacer, which was made by aluminium mold and loaded: Imipenem 2 g, and Vancomycin 2 g (Synovial fluid tests result: Staphy-lococcus aureus, multiple antibiotic resistance). He was discharged after 2 weeks with the infection in control, dry wound. He keeps on using oral antibiotic treatment in 6 weeks (Figure 5).

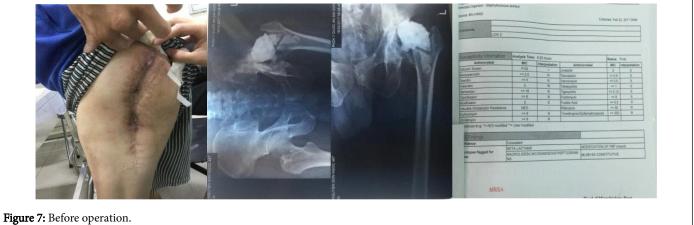
At Cho Ray hospital, he underwent debridement 3 times and VAC drainage, and replaced an intra-operative production of antibioticloaded cement spacer, which combined 2 packs cement 40 g, 1,2 g Teicoplanin and 2 g Vancomycin (Synovial fluid tests result: Staphylococcus aureus, MRSA). After 2 weeks, he was discharged with healing wound. He also kept on using oral antibiotic treatment in 6 weeks (Figure 7).

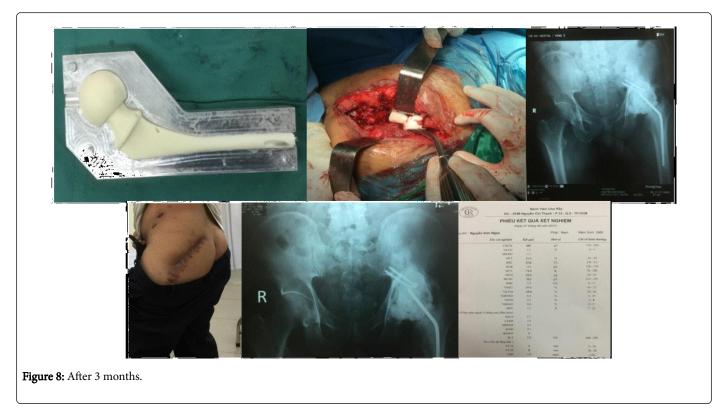
After 3 months, he checked up in Cho Ray hospital, his wound was healed, left leg function was good, and infectious condition was improved. Serological Tests: WBC: normal, ESR: normal, CRP: 2,9 mg/L (Figure 8).
